Production of Solid Sustainable Energy Carriers from Biomass by Means of Torrefaction

Deliverable No. D6.7

Final report on bulk tests in existing storage and handling facilities

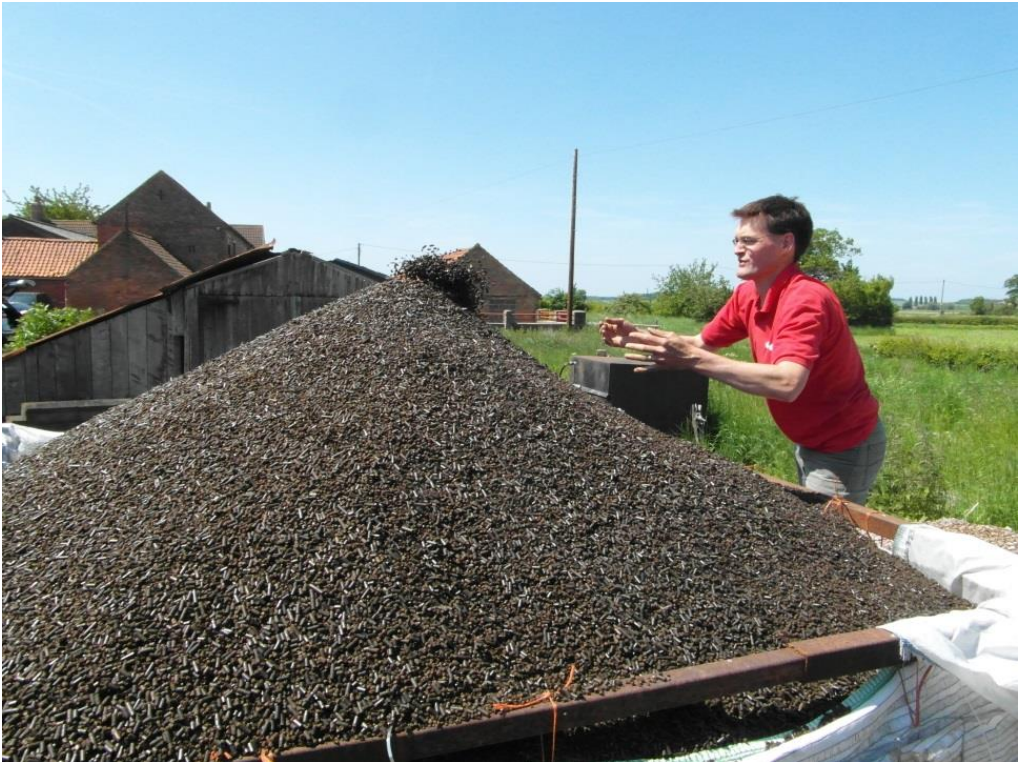
Figure 4: Completion of peak pile

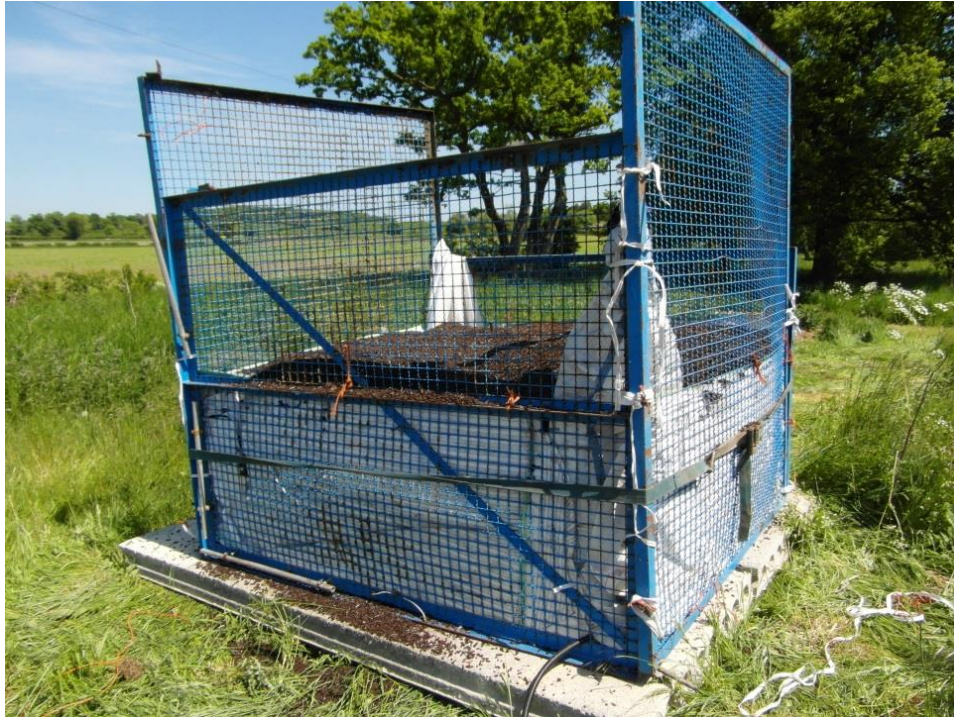
Figure 5: Completed flat pile

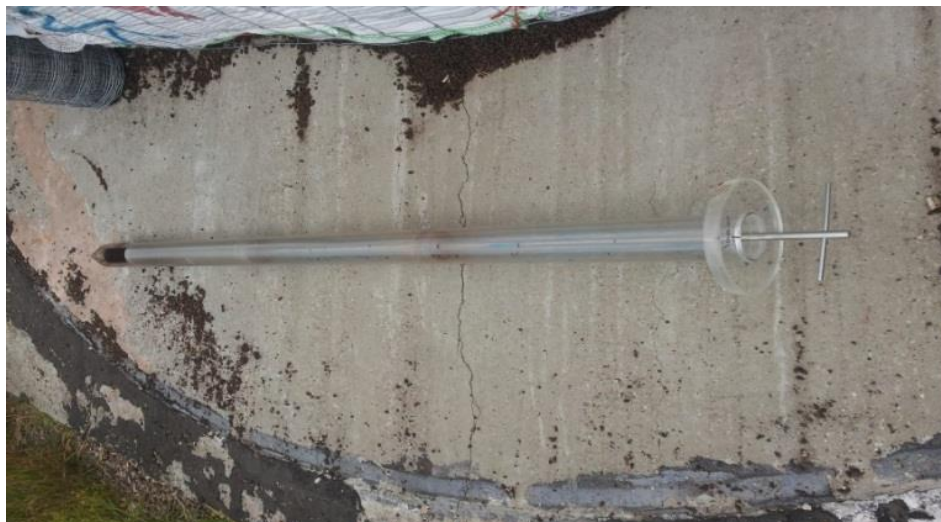
Figure 7: Sampling spear

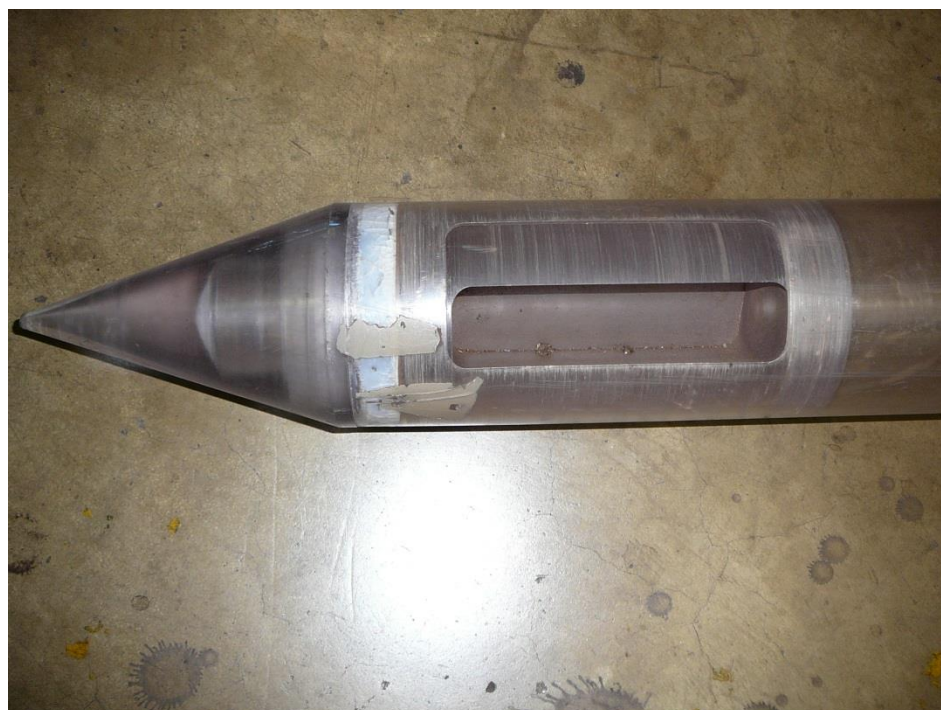
Figure 8: Spike of sampling spear, showing rotating trapdoor (half open)

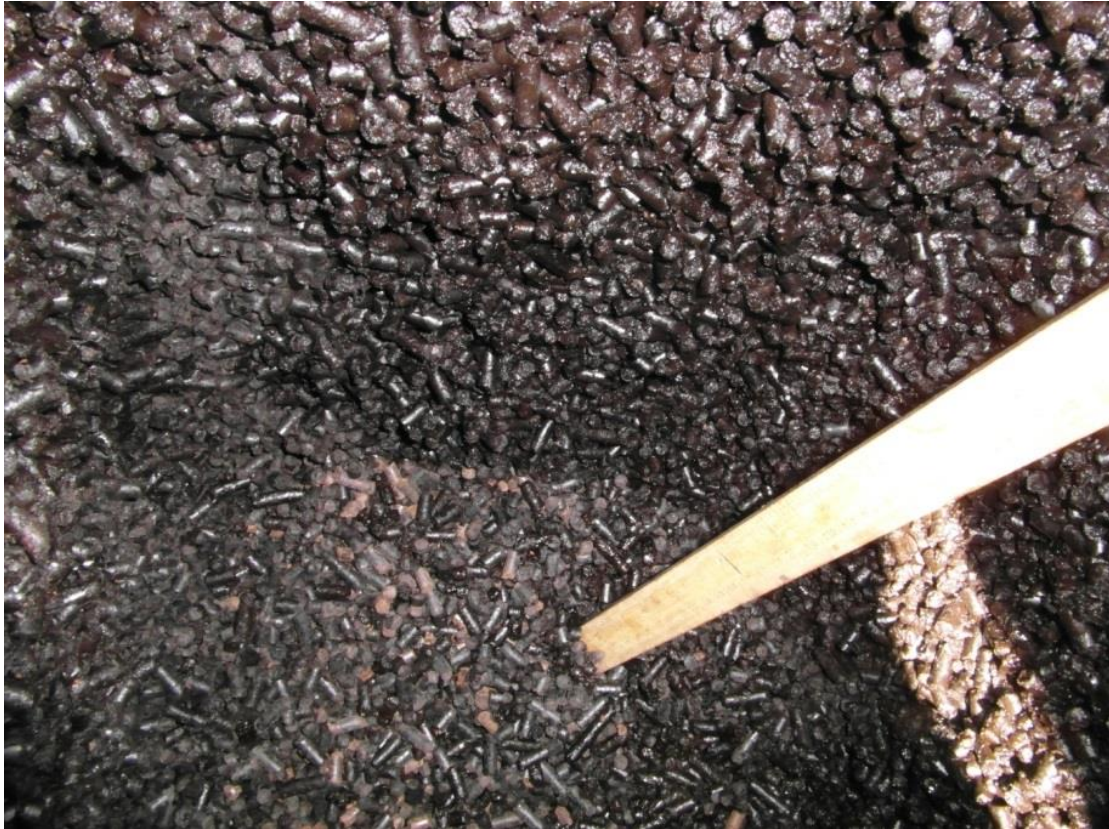
Figure 13: Sampling "pit" in flat pile

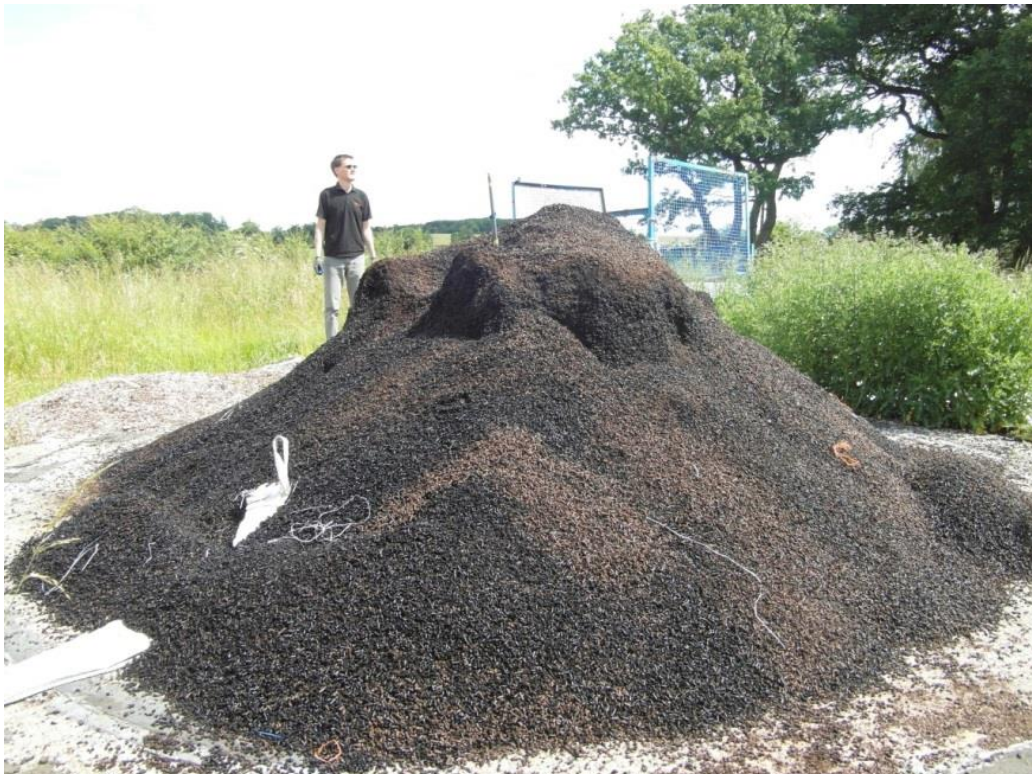
Figure 14: Peak pile after removal of supporting cage

The loss of the free-flowing characteristic of the material was particularly noticeable during the take-down of the piles, where a central core of material remained after the surrounding cages were removed (see Figure 14 & Figure 15).

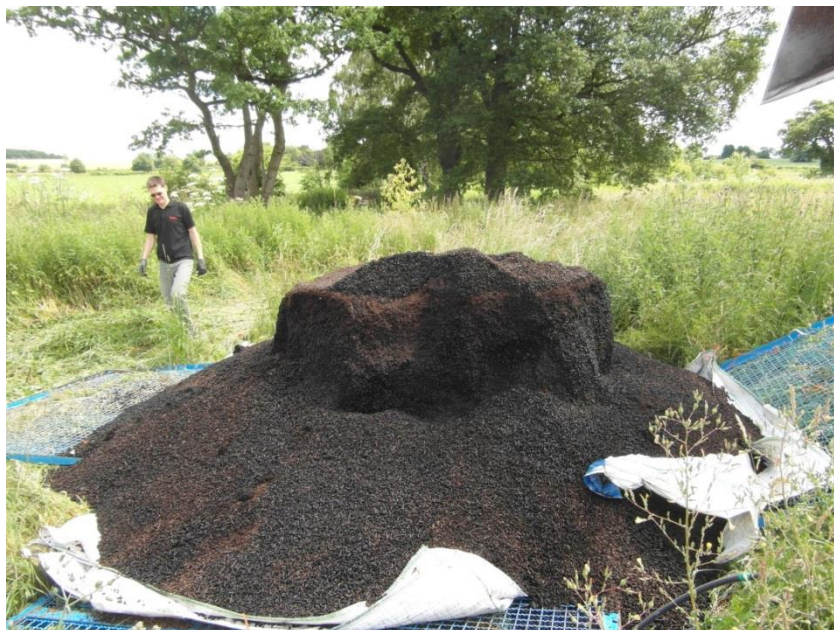
Figure 15: Flat pile immediately after removal of supporting walls

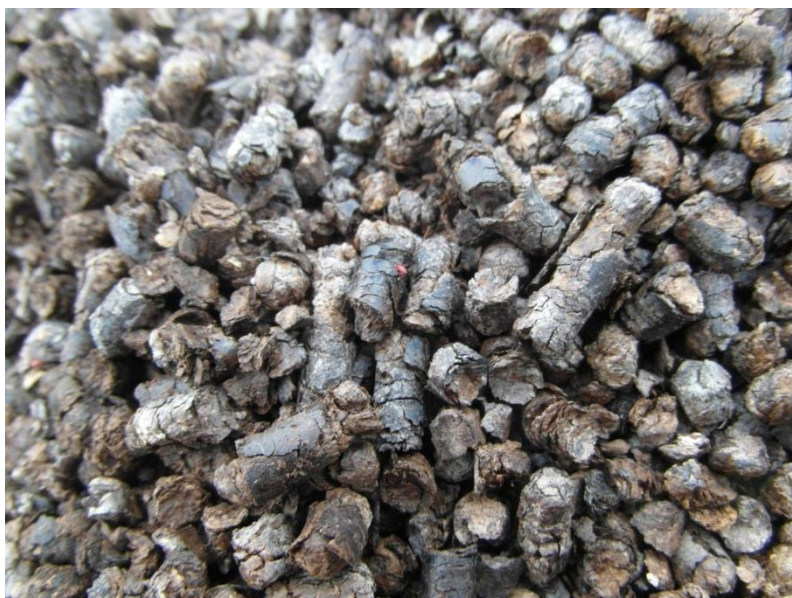
Figure 16: Pellets at the surface of the peak pile

By the time of the pile take-down, distinct layers of the stockpile were noticeable. The surface layer composed of visibly degraded pellets but with low levels of fines (defined as material which passes a 3.15mm round-hole sieve), whose moisture content varied according to the ambient weather conditions during the sampling (Figure 16). Just below was a layer of very wet material, with a high proportion of fines. This wet layer appeared to remain even when the site had been warm and sunny for a number of days prior to sampling. Underneath this the pellet was mainly very wet, although less degraded than the surface material. However, within this were pockets of pellet which appeared to be completely unchanged from the as received material, with low moisture content and a smooth, shiny surface. These pockets appeared randomly distributed with the pile, and during take-down no correlation was observed between the location of the pockets and either contact with the retaining membrane or with the locations of previous sampling.

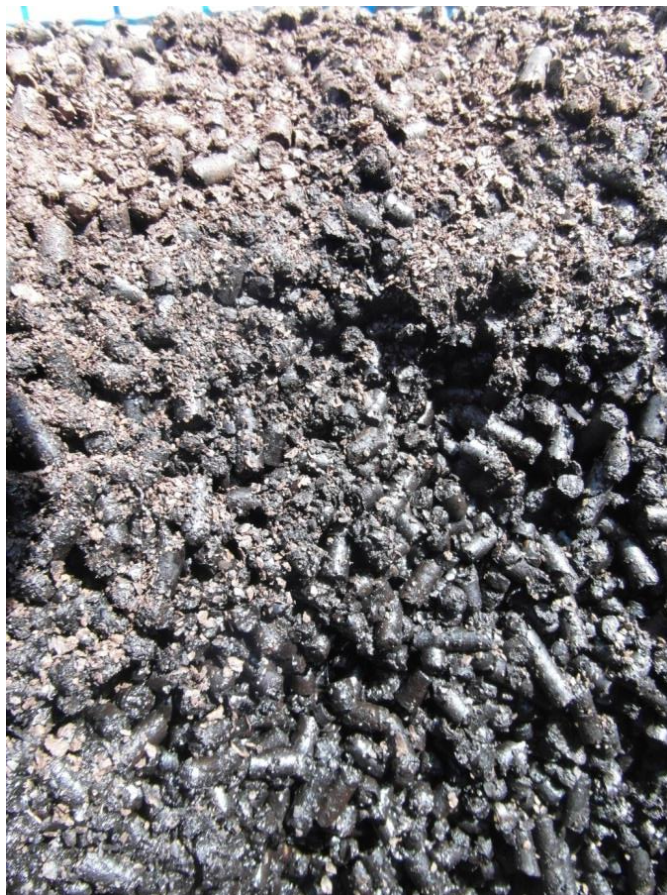
Figure 17: Cross section of top of flat pile, showing high fines layer above wetter pellet

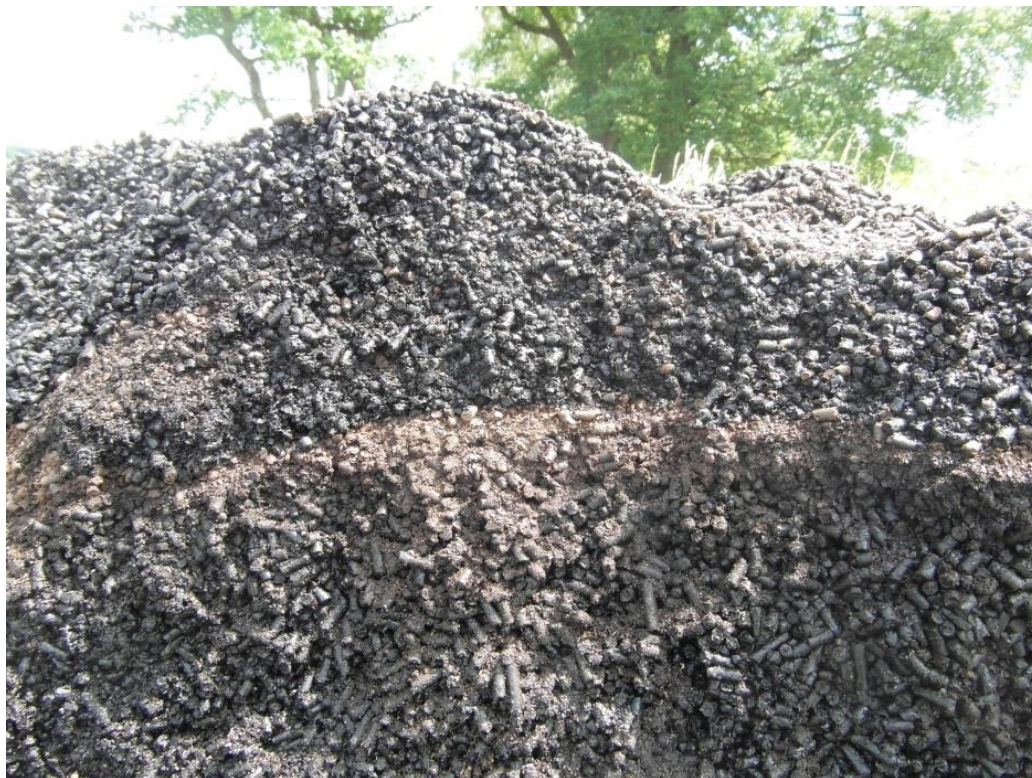
Figure 18: Vertical face of flat pile during dismantling, showing areas of pellets with different moisture contents

During the pile takedown, these drier areas were particularly noticeable as paler brown bands between the black areas of wet pellets – there was no obvious transition zone between the two, with dry and wet pellets in direct contact (Figure 18 & Figure 19). During the routine collection of “middle” samples, no distinction was made between the wet and dry material so the recorded results will be for a mixture of the two, but during the take-down of the peak pile, a specific sample of the dry pellet was removed from near the centre of the pile. This was shown to have a free moisture content of 6.7%, i.e. significantly lower than that of the general “middle” samples. The durability of 94.7% was also closer to that of the original material than the durability of the other samples taken during stockpile dismantling. Some of the very wet pellets removed from both piles had a tendency to clump together, with a brown liquid held at the surface (Figure 20).

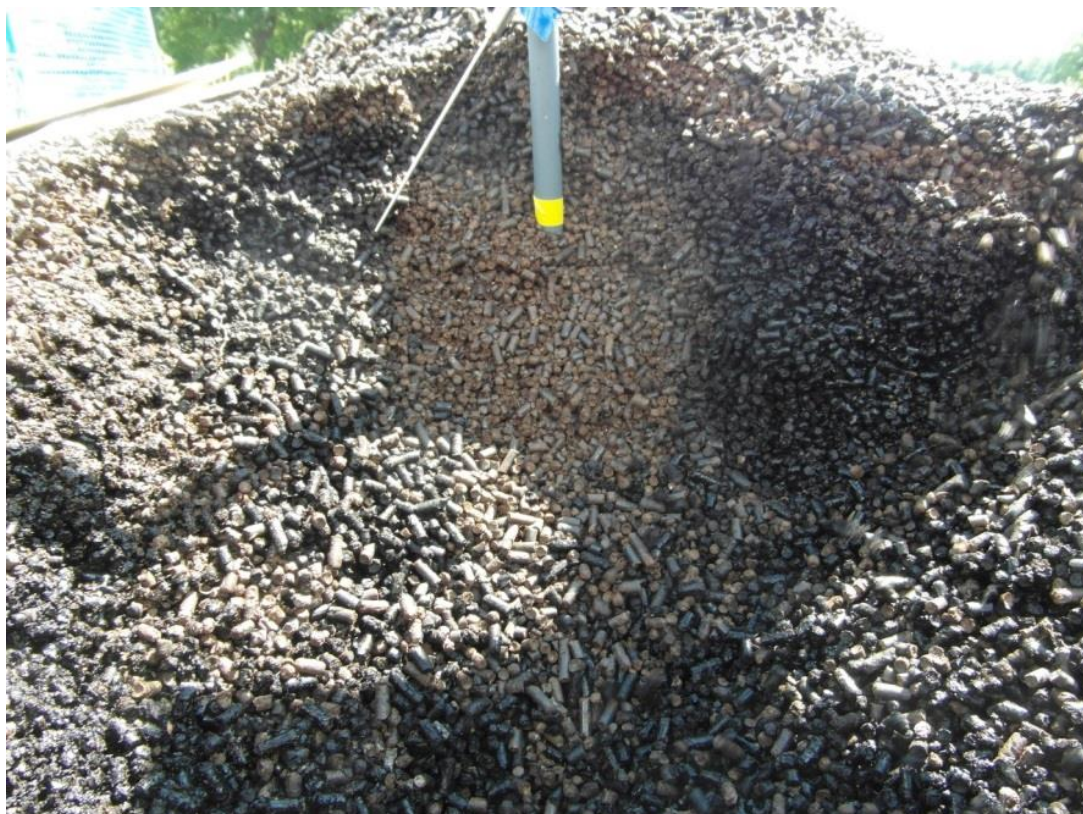
Figure 19: Interior of peak pile during dismantling

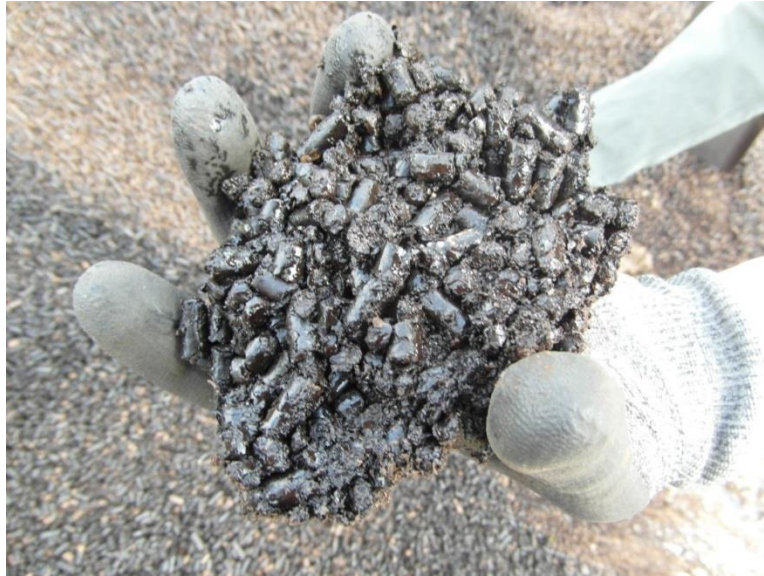
Figure 20: Clumping of the wet pellet

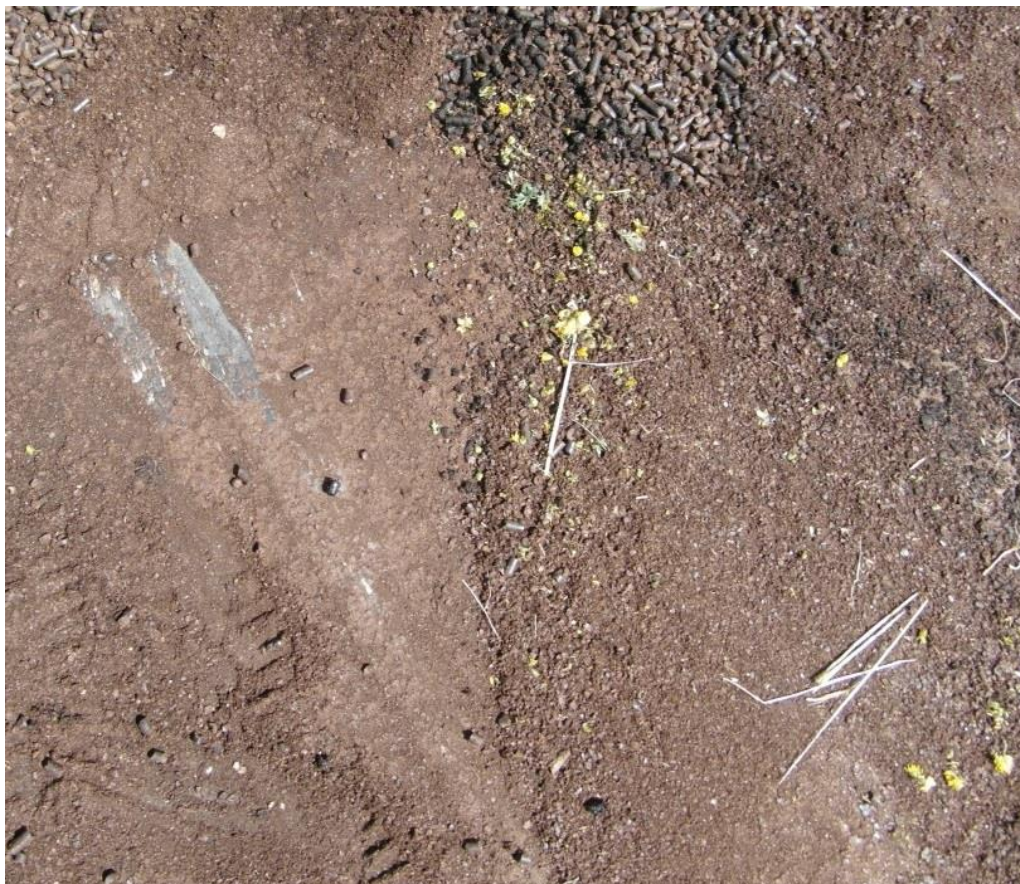
Figure 21: Base of peak pile

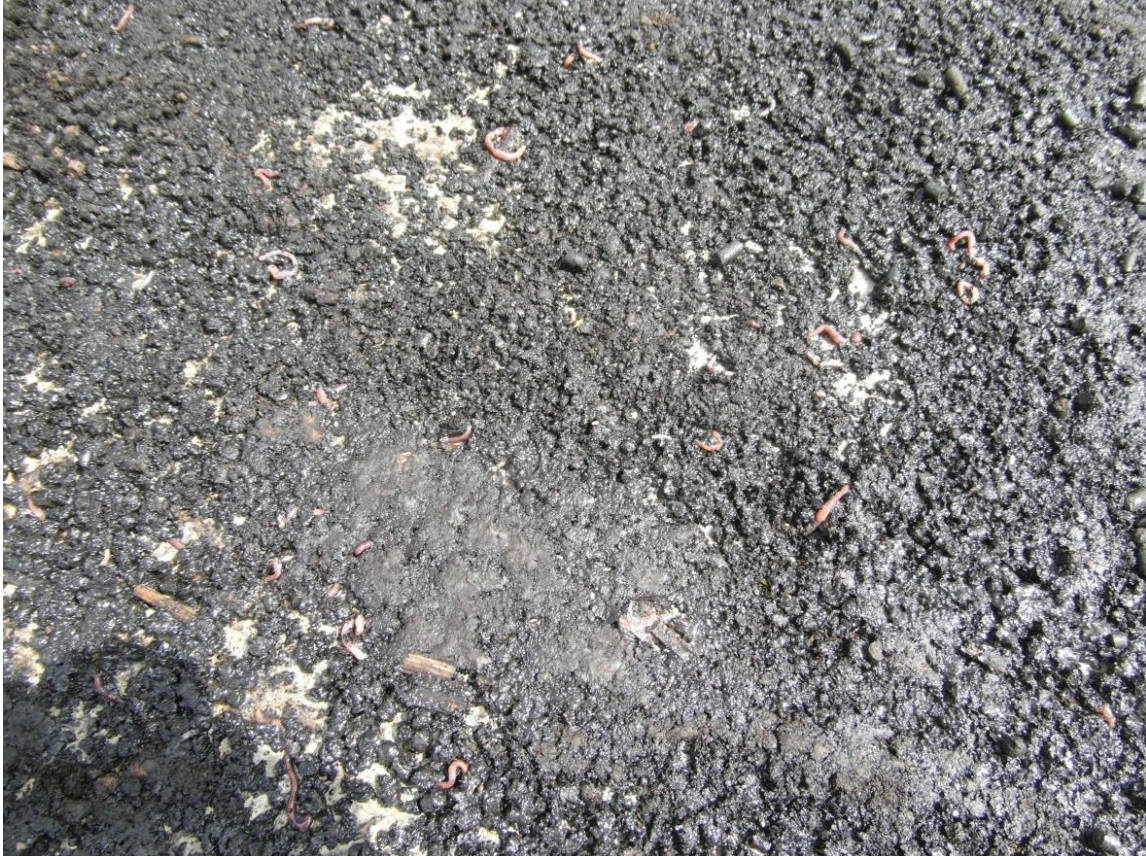
Figure 22: Base of flat pile, showing high levels of wet fines and earthworms

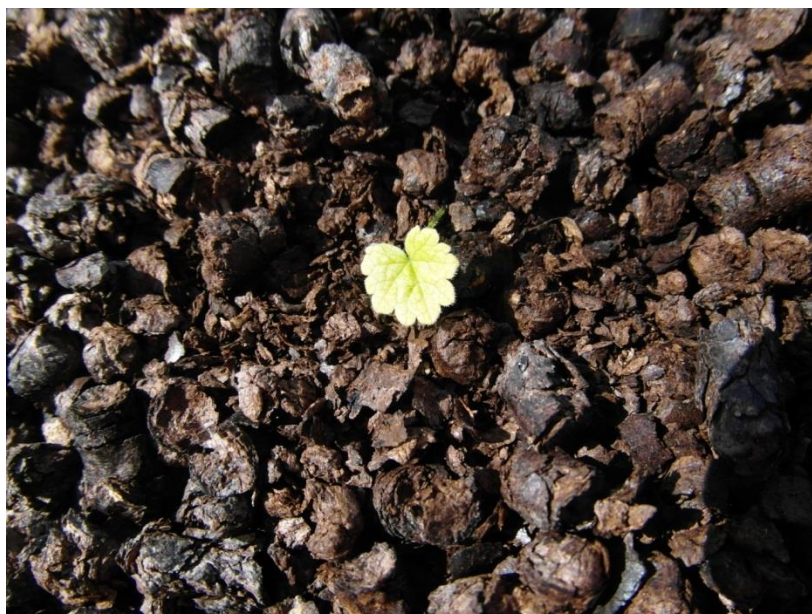
Figure 23: Seedling growth on peak pile

At various points during the test, limited biological activity on the pile was observed, particularly the growth of plant seedlings on the surface of the peak pile (Figure 23). In general, these were removed by the test team. During removal of the flat pile, it was noticeable that at the bottom of the pile were a high number of earthworms, although these had not been noticeable within the rest of the material (Figure 22). Visible fungal growth was not however observed in either pile.

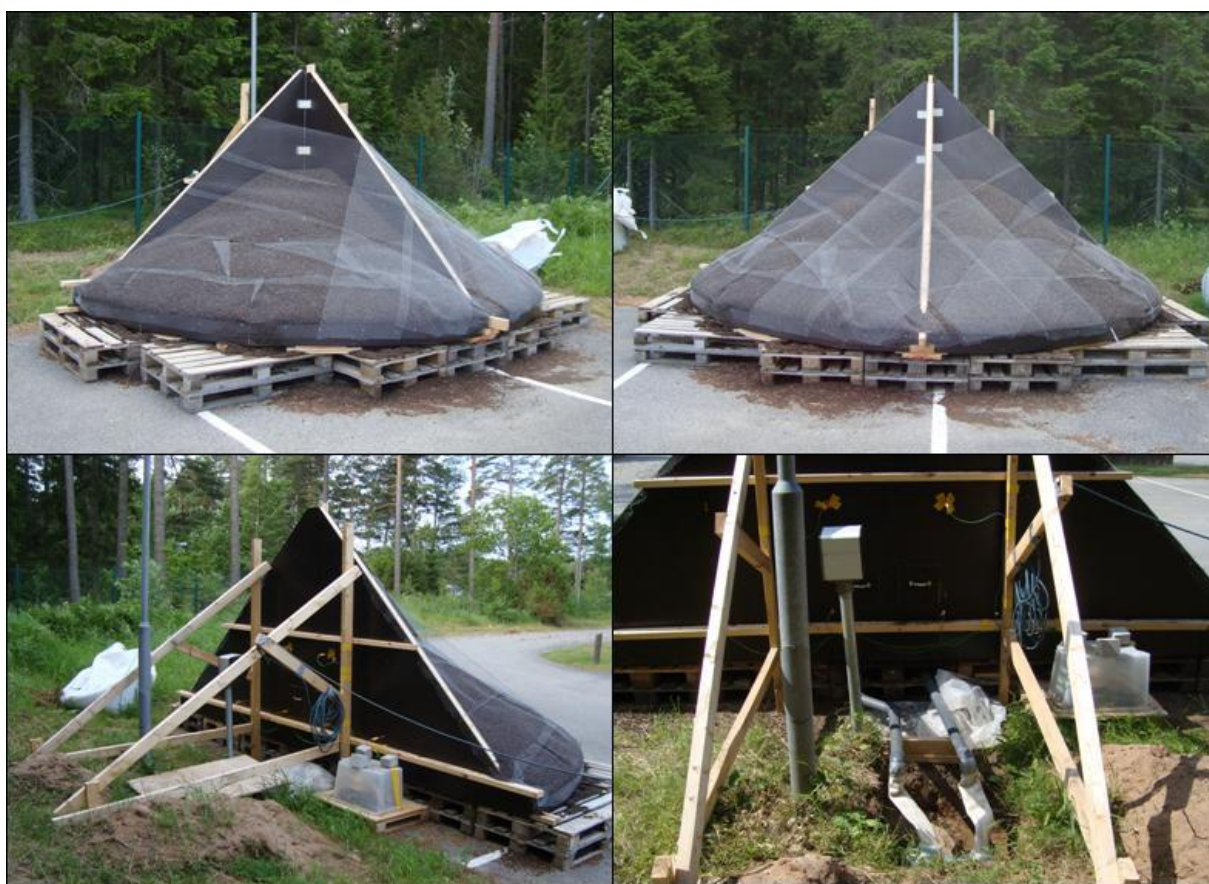
Figure 33: Outdoor storage construction used for testing of the SECTOR spruce and poplar pellets at Vattenfall's R&D centre in Älvkarleby, Sweden.

The storage construction was designed in water repellent plywood in order not to accumulate moisture in the construction itself that potentially could impact the results. Two hatches were added on the back to allow easy access for sampling of pellets (one hatch for each quality of pellets tested). The construction was also designed with a bottom with a slight angle of inclination in order to collect and lead any leach water produced during the test period to a pipe and subsequent leach water storage containers.

During the trials the spruce pellets have been facing north-west while the poplar pellets have been facing south-west. The back of the storage construction has consequently been facing east.

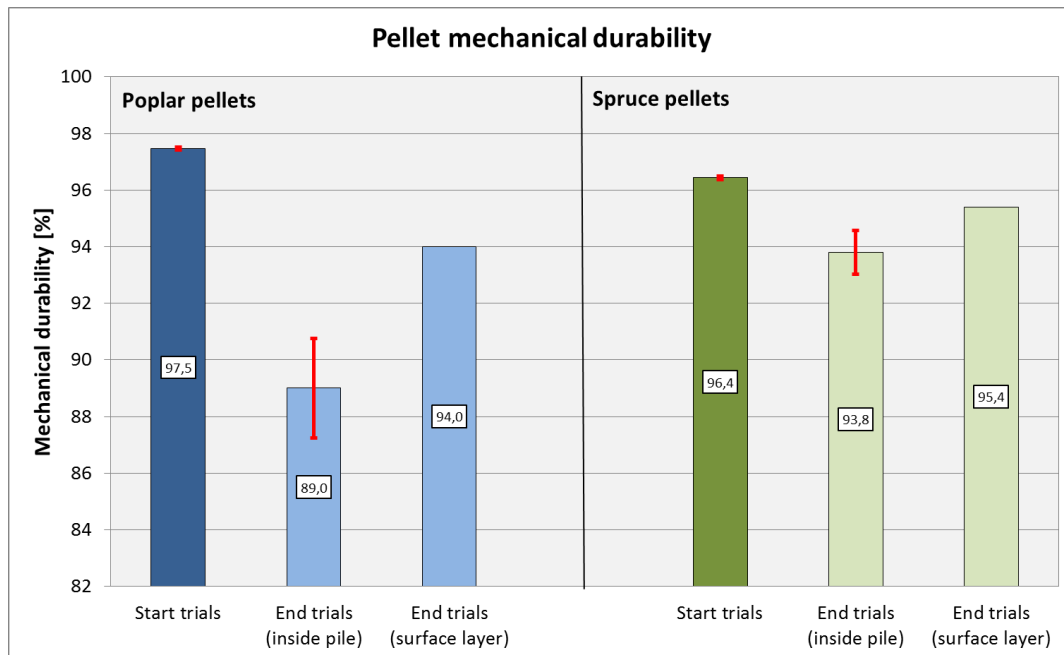
Figure 42: Mechanical durability of the SECTOR pellets samples at the start and end of the ~9 month test period.

As can be seen from the figure there is a decrease in mechanical durability during the test period, but not as severe as expected. The poplar pellets seem to exhibit the largest decrease in mechanical durability with roughly 8.5% (from ~97.5% down to 89%), while the spruce pellets only exhibit a minor reduction of ~2.6% (From ~96.4 down to 93.8%).

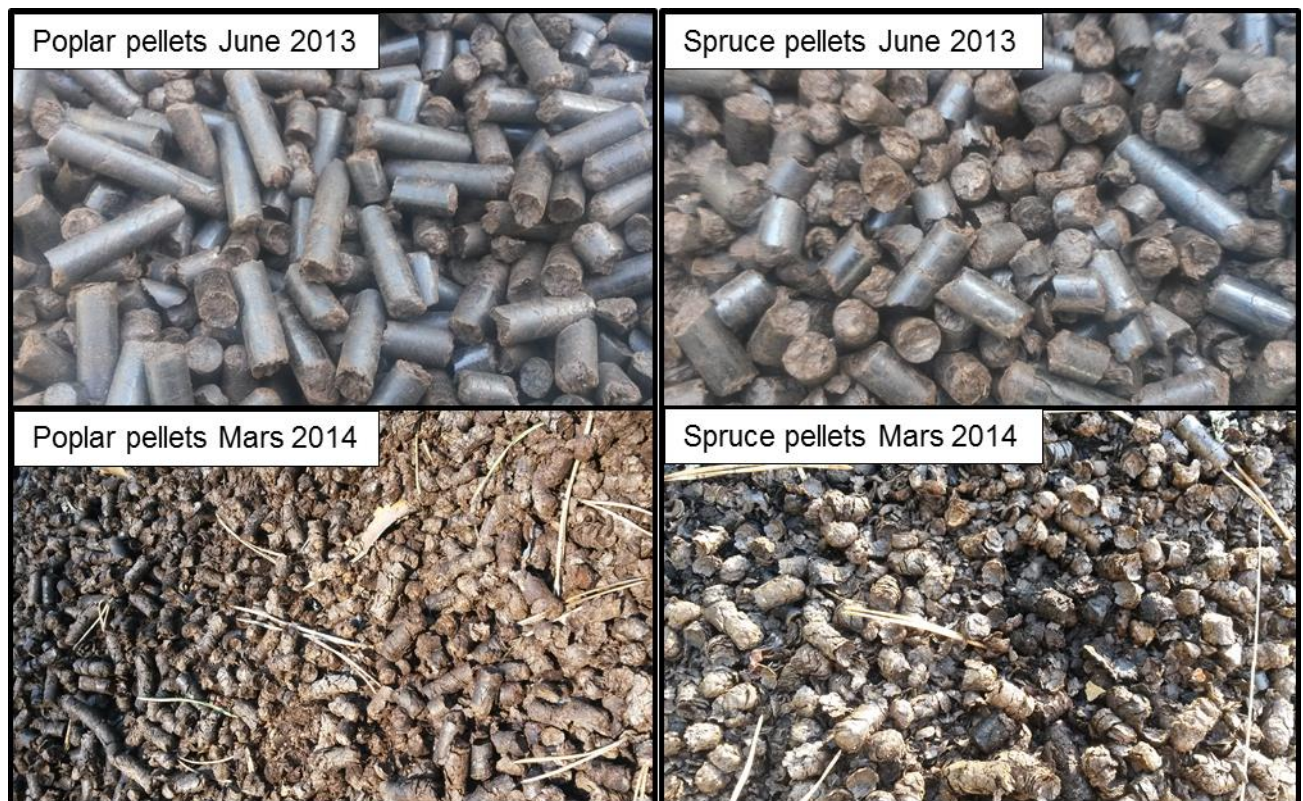
Figure 43: The poplar and spruce pellets at start and end of the 9 month outdoor storage period. The pellets close to the surface have a considerably rougher appearance compared to the original conditions. There is also a significant amount of fines from disintegrated pellets close to the surface.

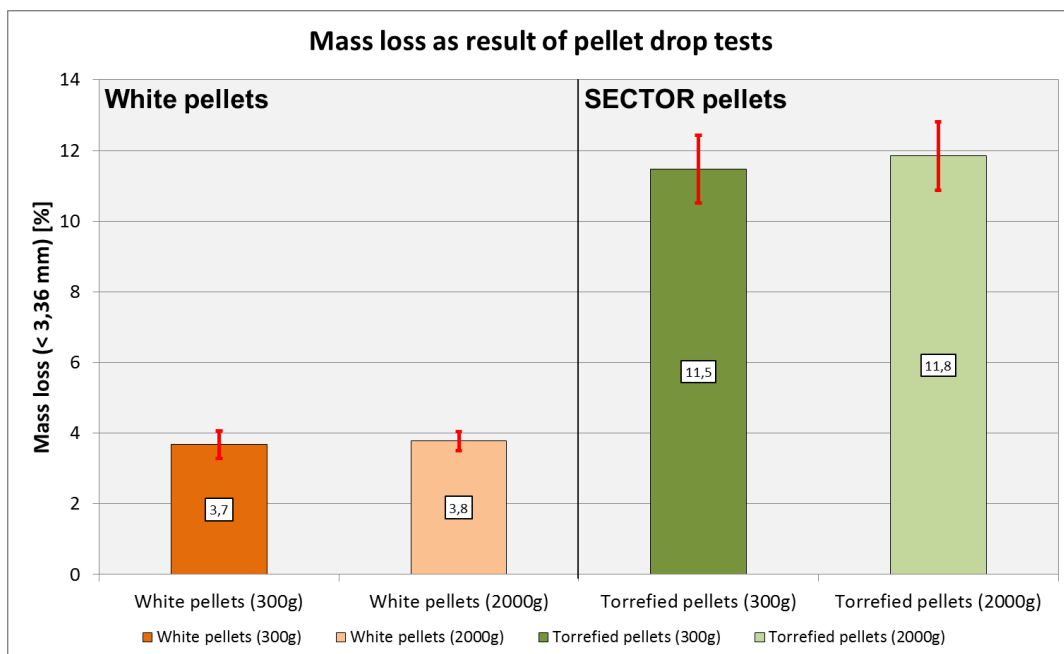
Figure 44: Summary of the results from the drop tests. From the test it can be clearly concluded that the torrefied pellets have a significantly higher degree of fine particle loss compared to the reference white pellet samples.

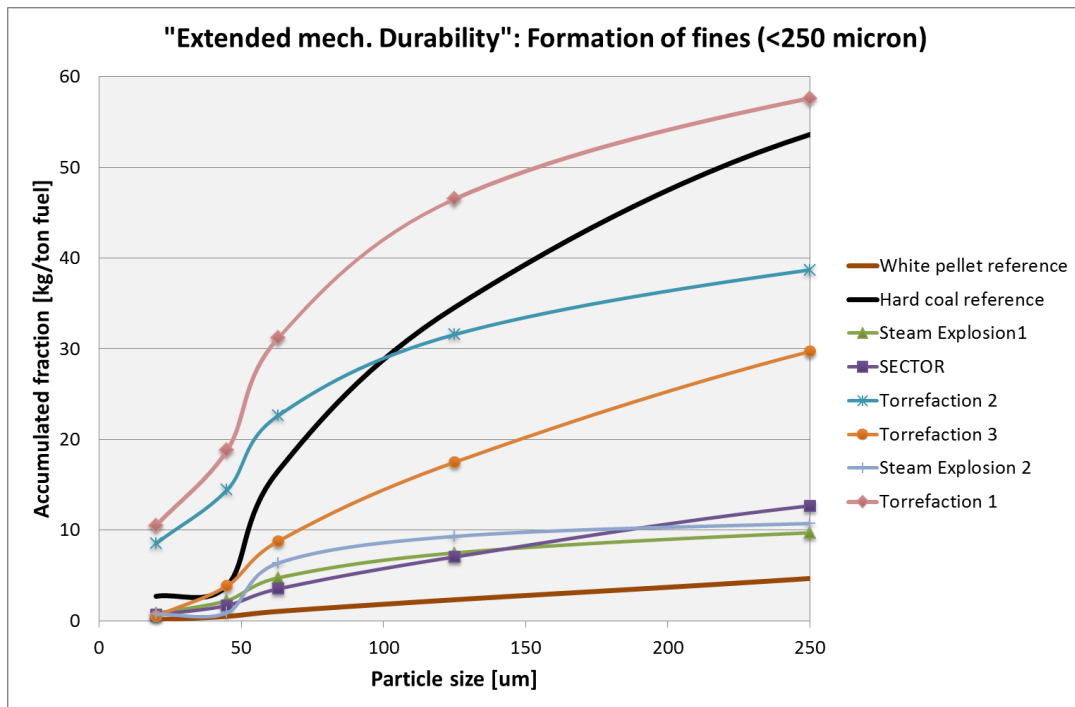
Figure 45: Summary of the expected fine dust formation (< 250 μm) according to the extended mechanical durability test. Please note that comparison between the coal and biomass samples should be done with certain care as dust formation from coal normally is established according to different standards.

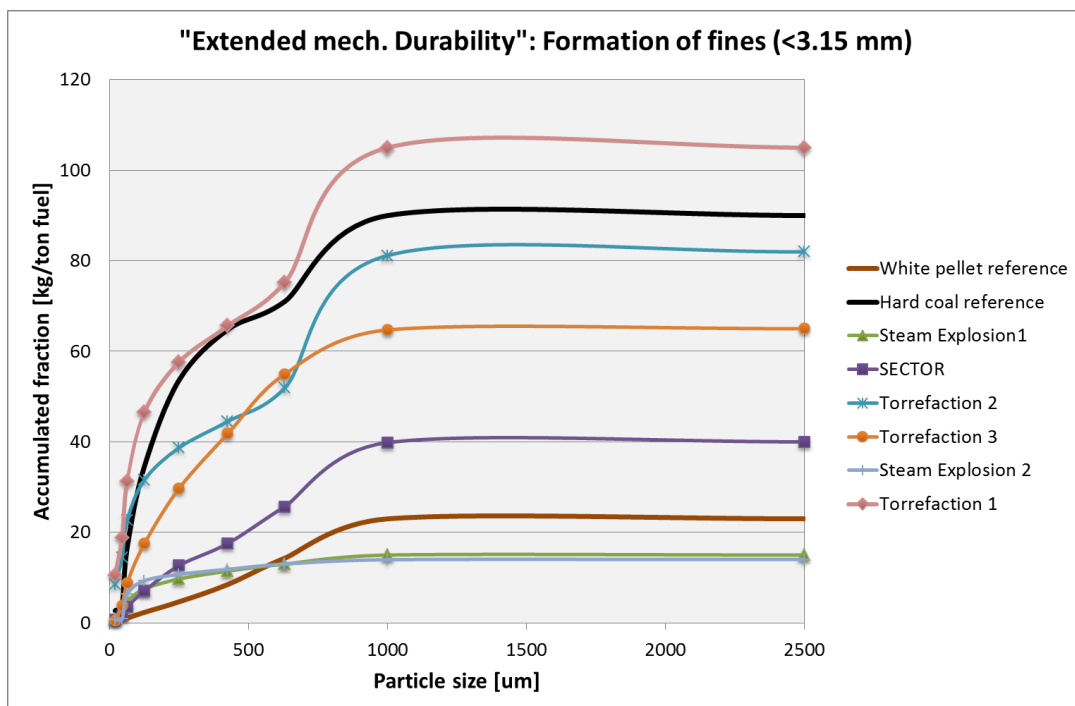
Figure 46: Summary of the expected fine dust formation (< 3.15 mm) according to the extended mechanical durability test. Please note that comparison between the coal and biomass samples should be done with certain care as dust formation from coal normally is established according to different standards.

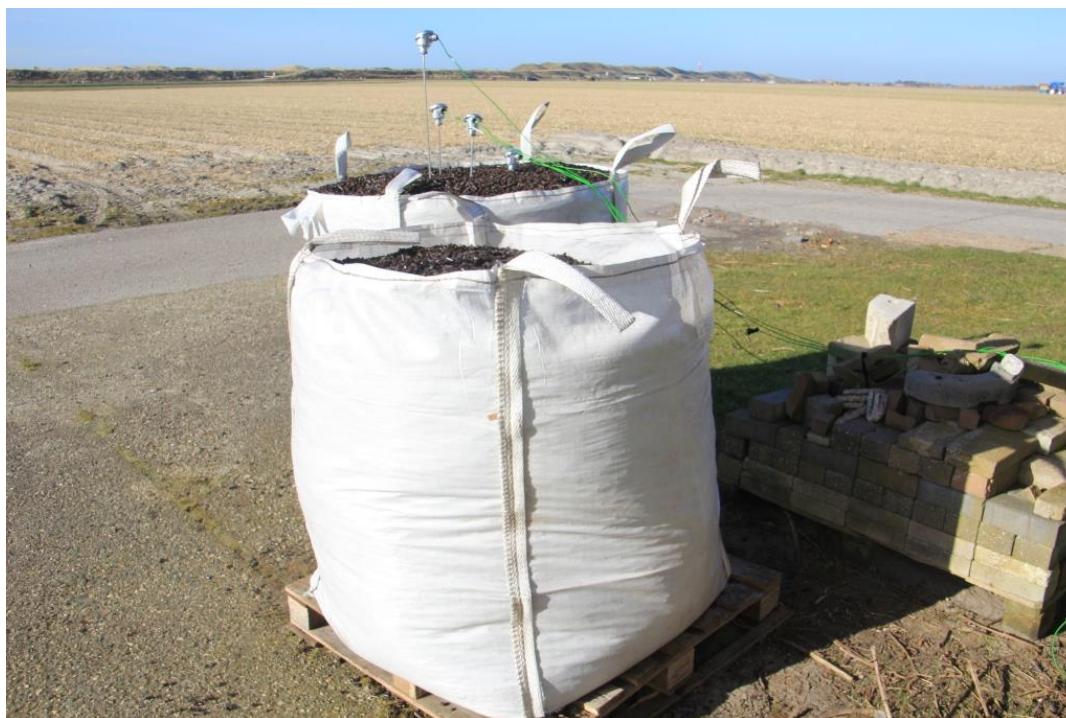
Figure 48: Test set up with thermocouples in pile 2

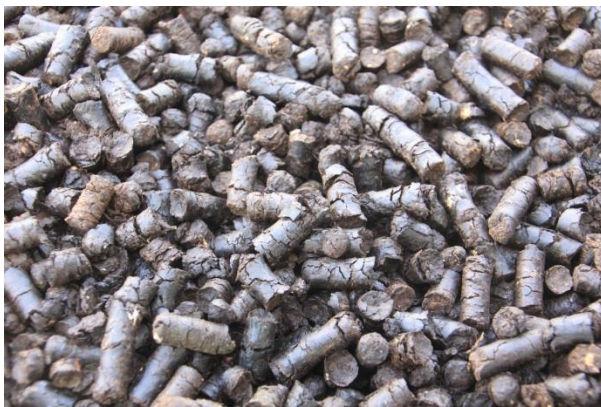
Figure 53: Slow degradation of top layer

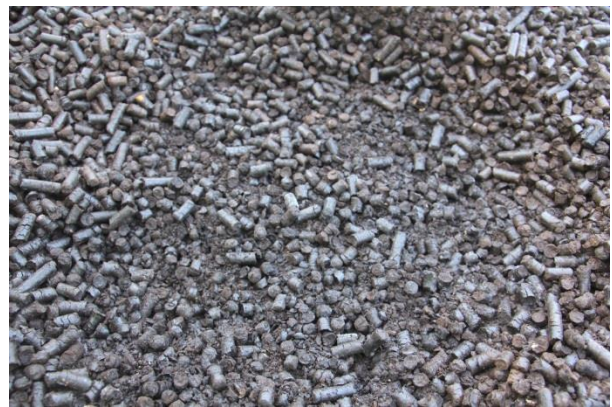
Figure 54: Layer of fines at 10cm depth

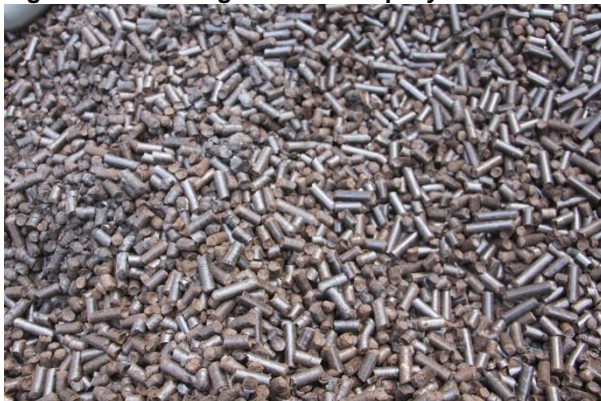
Figure 55: Pellets at 20cm depth

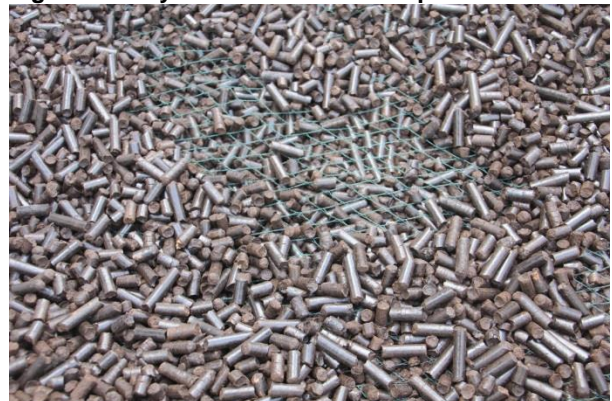
Figure 56: Pellet at 80cm depth

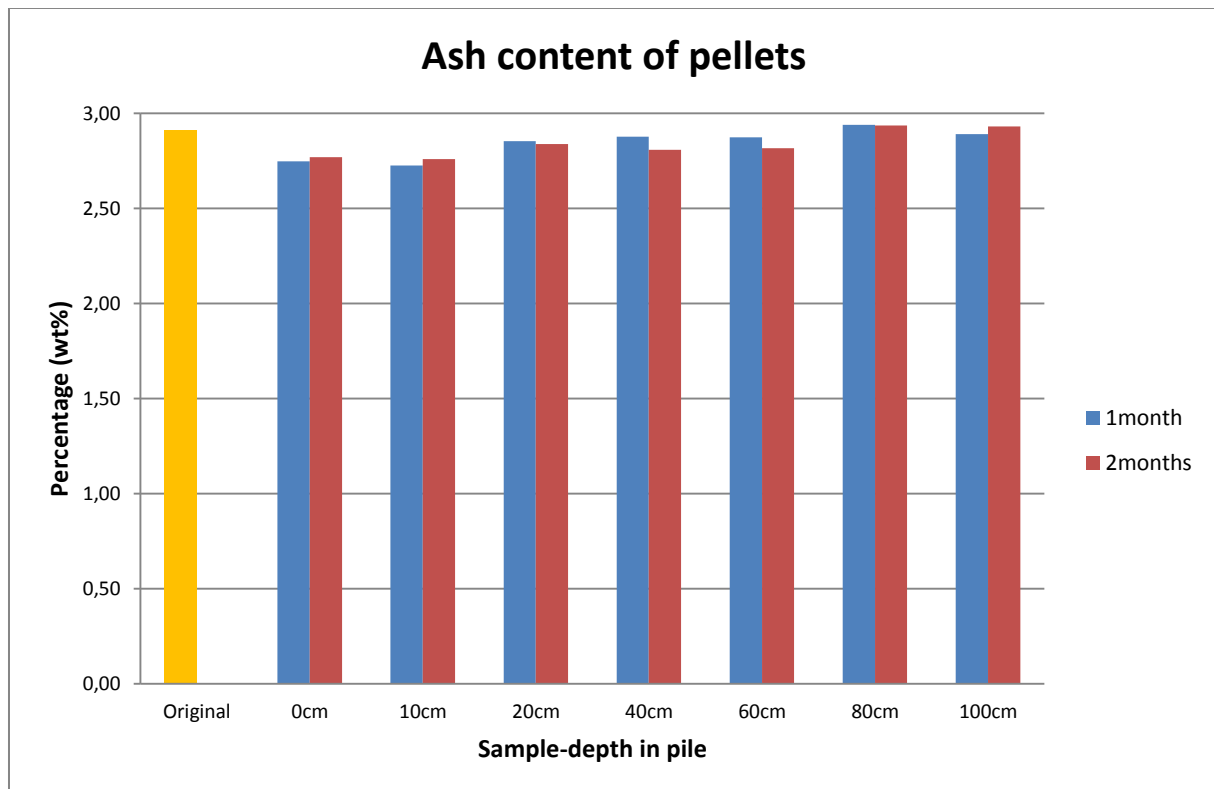
Figure 58: Ash content analysis results of all samples on dry basis.
